Manhole Inspection Summary

Manhole # S19A__024MH

Insp Date: **10/24/07 11:21 AM**

Location Address: **2011 LANVALE-RAYNOR**

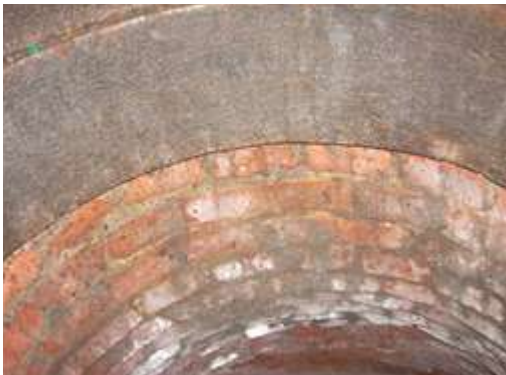
Defect 3

Infiltration: ☐ None ☒ **Joint** ☐ Cracks ☐ Mortar ☐ Roots ☒ **Wall**

INFILTRATION OF THE CORBEL JOINT AND WALL

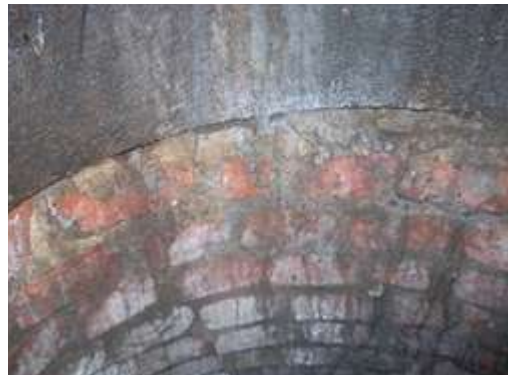
Defect 2

Condition: ☐ Sound ☐ Cracked ☐ Root Intrusion ☐ Loose Brick ☒ **Deteriorated**

DETERIORATED CORBEL

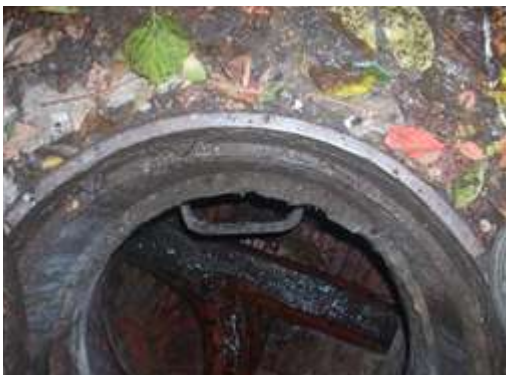
Defect 1

Offset: **1** (in.)

FRAME OFFSET

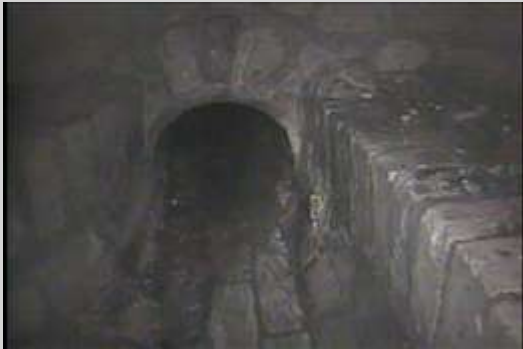
12 O'Clock Outflow

Pipe Height: **7.2** (in.) Rod and Bar (Angled)
Pipe Material: **Clay** ☐ Pipe Lined
Invert Depth: **6.81** (ft.) Flow Characteristics: **Slow**
Deposits: ☒ None ☐ Mud ☐ Sludge ☐ Debris ☐ Grease
Silt Depth: (in.) Deposits Extent:
Infiltration: **None** Pipe Seal Cond: **Sound**

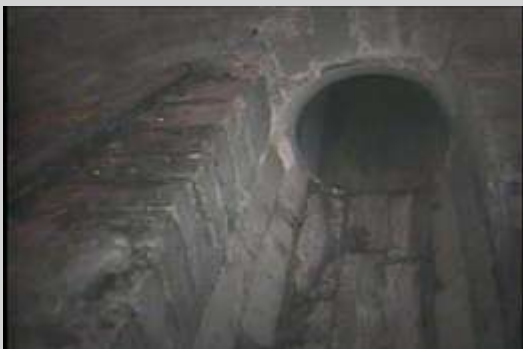
6 O'Clock Inflow

Pipe Height: **8.4** (in.) Rod and Bar (Angled)
Pipe Material: **Clay** ☐ Pipe Lined
Invert Depth: **6.60** (ft.) Flow Characteristics: **Slow**
Deposits: ☒ None ☐ Mud ☐ Sludge ☐ Debris ☐ Grease
Silt Depth: (in.) Deposits Extent:
Infiltration: **None** Pipe Seal Cond: **Sound**

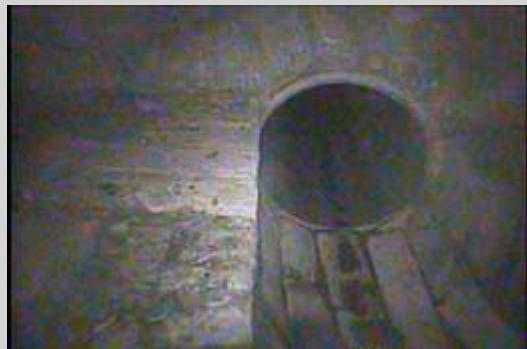
9 O'Clock Inflow

Pipe Height: **7.2** (in.) Rod and Bar (Angled)

Infiltration: **None** Pipe Seal Cond: **Sound**
